1N-23
3802
NASA Contractor Report 4586

Analysis of Selected Materials Flown on Interior Locations of the Long Duration Exposure Facility

H. A. Smith, K. M. Nelson, D. Eash, and H. G. Pippin

Contracts NAS1-18224 and NAS1-19247
Prepared for Langley Research Center

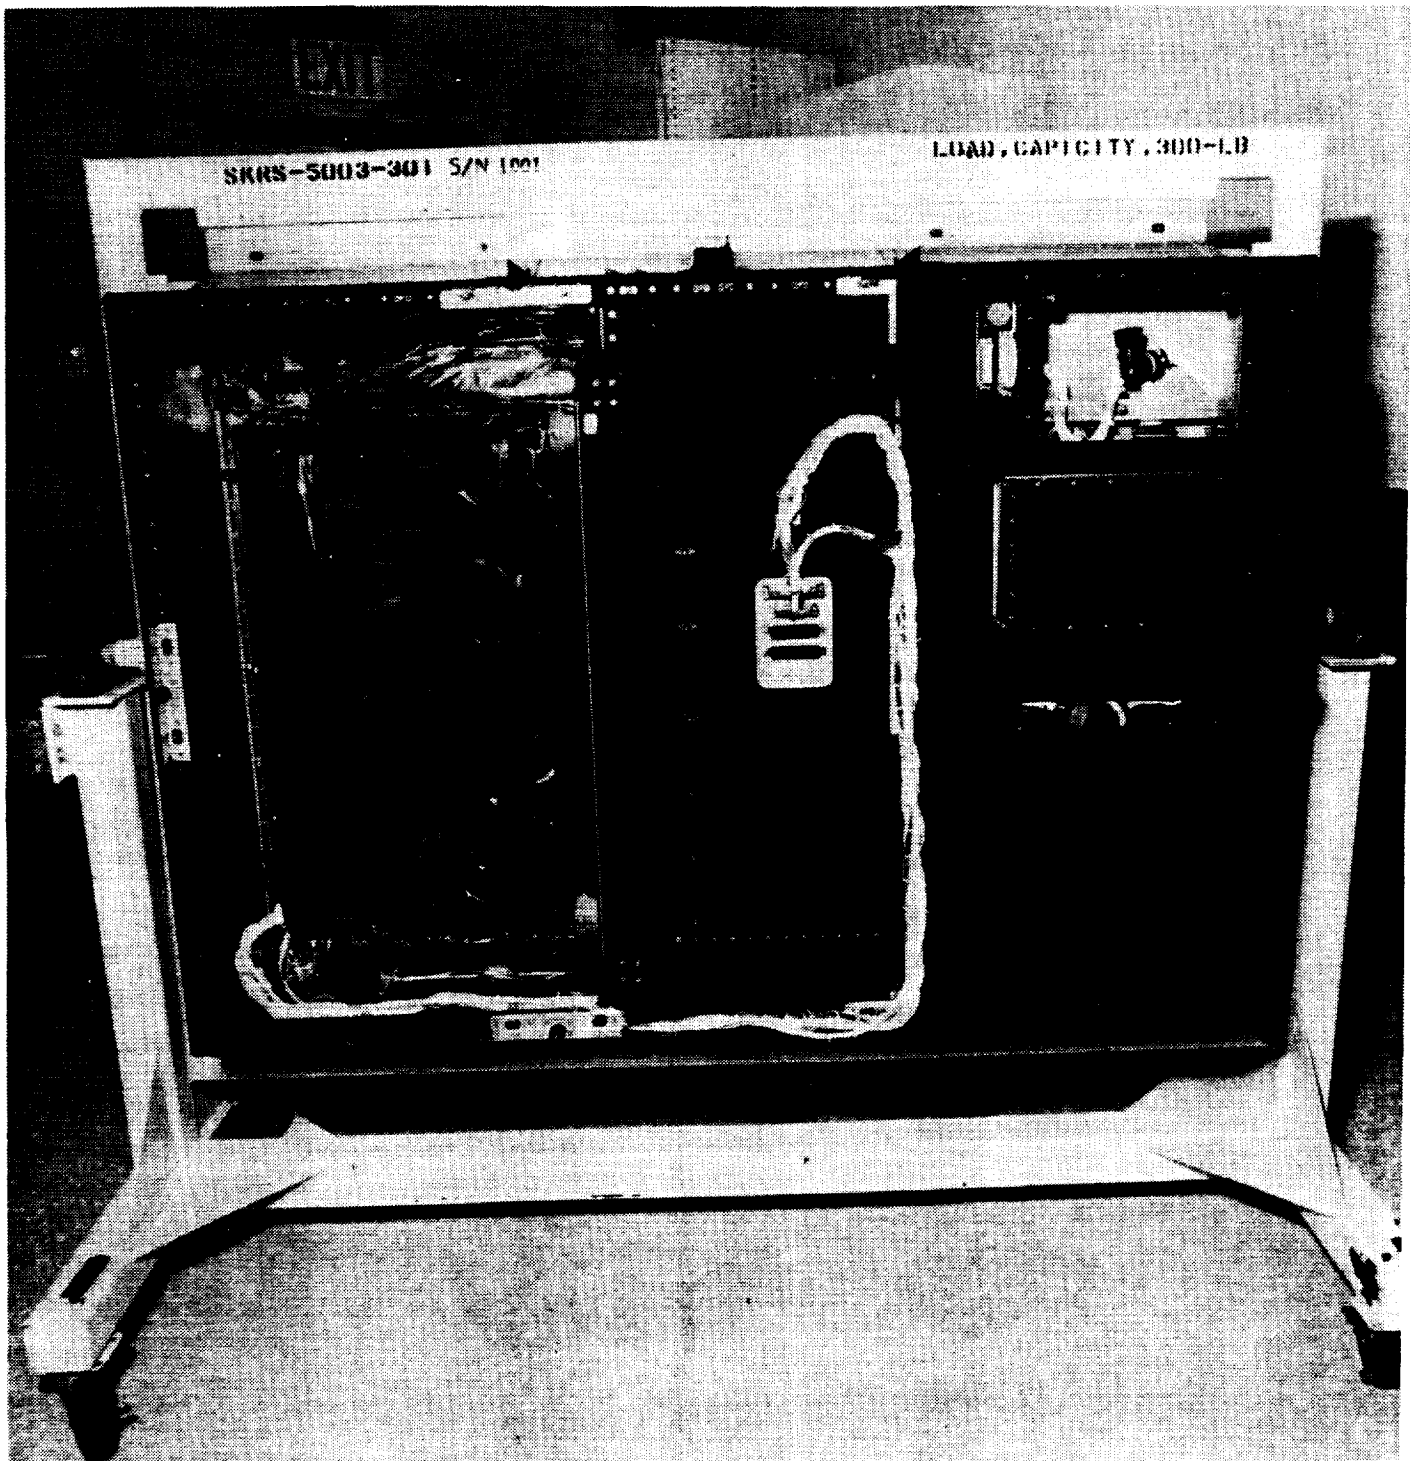
KaptonTM thermal control blankets used on the interior facing sides of experiment trays appeared in excellent condition subsequent to the flight. Figure 9 shows a representative tray containing this material. The viscous damper shroud included a dome of spun aluminum. This half-sphere was mounted at the space end interior and maintained its mirrored surface. One area of the shroud dome had a thin molecular film deposit with a distinct diffraction pattern. The shape and color pattern of the deposit showed that one specific contamination source created this film. The remainder of the damper shroud was adhesive backed tape attached to a fiberglass shell. This material appeared in excellent condition. The TeflonTM coating on the interior wiring also appeared to be in excellent condition after the flight. The areas of the LDEF structure painted with Z-306 (Chemglaze, now Lord Chemical) black paint appeared unchanged except for areas with contamination deposits. An example of the deposition patterns from venting through holes for fastening tray lids appearing on the longeron is shown in figure 10. Figure 11 shows contaminant film shadow patterns on the Z-306 painted interior side of tray B4. The pattern was caused by interference from a nearby structural support beam.

Figure 9. NASA post-flight photo of interior facing side of tray F12. Kapton thermal blanket on left appears specular. Wire bundles, paint, other hardware appear in good physical condition with little evidence of aging.

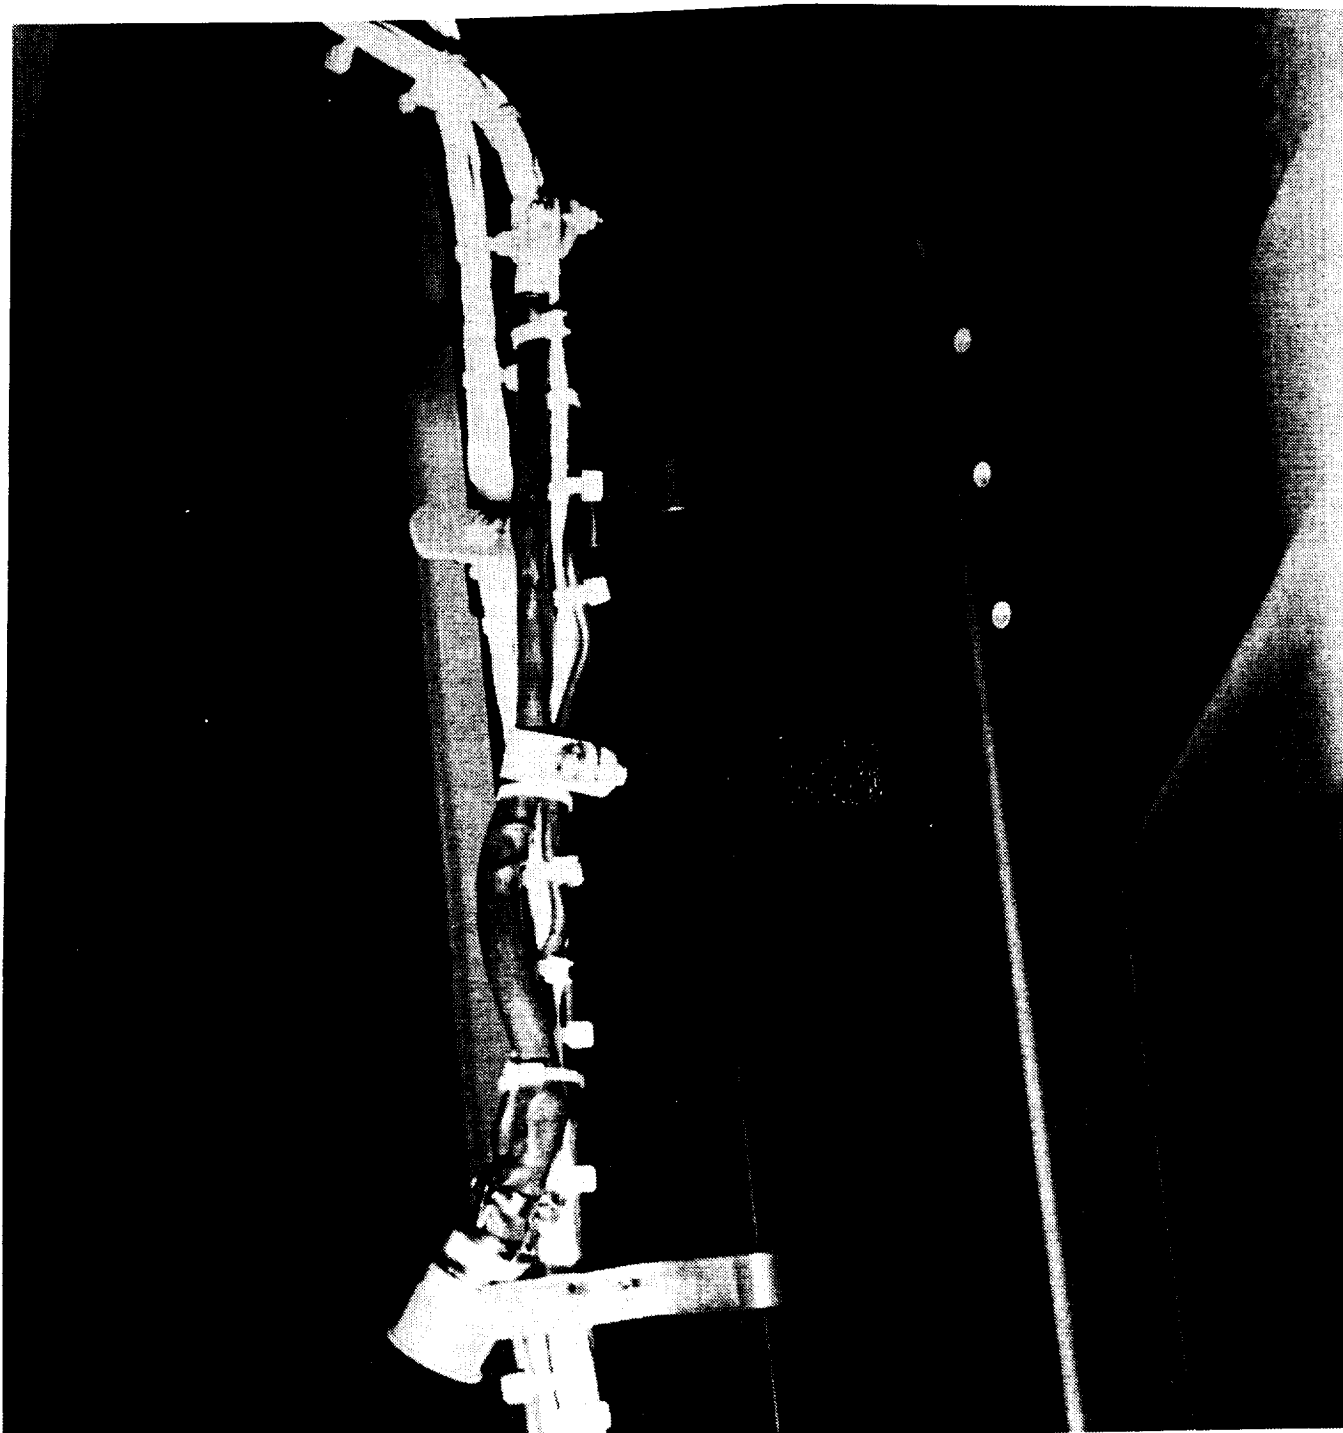
Visual inspection of the interior of LDEF in the SAEF-2 Building at KSC revealed distinct differences in the condition of areas on longerons between rows 3 and 4 near the wire harness clamps relative to areas around any other wire harness clamps. Teflon™ (PTFE) coated wire bundles, multi-layer insulation blankets, Z-306 painted surfaces, and a spun aluminum surface occupied large surface areas on the interior of the LDEF and except for contamination at specific locations, appeared visually to be unchanged as a result of the flight. The nylon wire harness clamps appeared to be slightly embrittled due to their space exposure. The heat shrink tubing flown outgassed less than the ground control specimens. The extent of bake-out varied from location to location. The glass transition temperature of the heat shrink tubing material flown was virtually unchanged relative to the ground controls.

The heat shrink tubing and/or fiberglass composite shims on the trailing edge longeron may have outgassed more than similar hardware at other locations. Damage to heat shrink tubing on clamps mounted on the interior of longerons between rows 3 and 4 may have been caused by periodic exposure to solar radiation and/or atomic oxygen through gaps at the corners of trays on the leading edge. Certain interior trailing edge locations were line of sight to the gaps. Solar exposure would have been sweeping and oxygen exposure continual. Outgassed material from the heat shrink tubing and fiberglass shims also may have darkened due to ultraviolet radiation exposure after condensing on the surface. However, no similar darkened outgassed material was visible around heat shrink tubing located between rows 8 and 9, even though these locations should have received similar amounts of heating from solar UV through gaps in the trailing edge hardware. It is also possible that differences in observed outgassing from heat shrink tubing specimens from different locations is because of subtle differences in the thermal histories of each clamp in orbit. Thermogravimetric analysis of selected tubing specimens showed essentially no difference between flight specimens and ground control specimens. The areas on the trailing edge longeron were darker than corresponding areas in other locations. Thermal data from the M0003 experiment (ref. 6) shows a temperature range about 5-10°C higher for tray D8 than for tray D4. This could have effected the long term residual curing of specific heat shrink tubing specimens and changed their outgassing characteristics. However, the specifics of each location; thermal mass differences, optical properties of the surfaces, and shadowing by nearby structure, leave large uncertainties in the actual thermal histories at each location. Essentially, the heat shrink tubing specimens each performed their task. All specimens were in-place and intact at the end of mission.

Figure 12. NASA photo of wire harness clamps with heat shrink tubing mounted on the longeron between rows 3 and 4, Bay C. The covered receptacle is pointed toward the Earth end of LDEF.

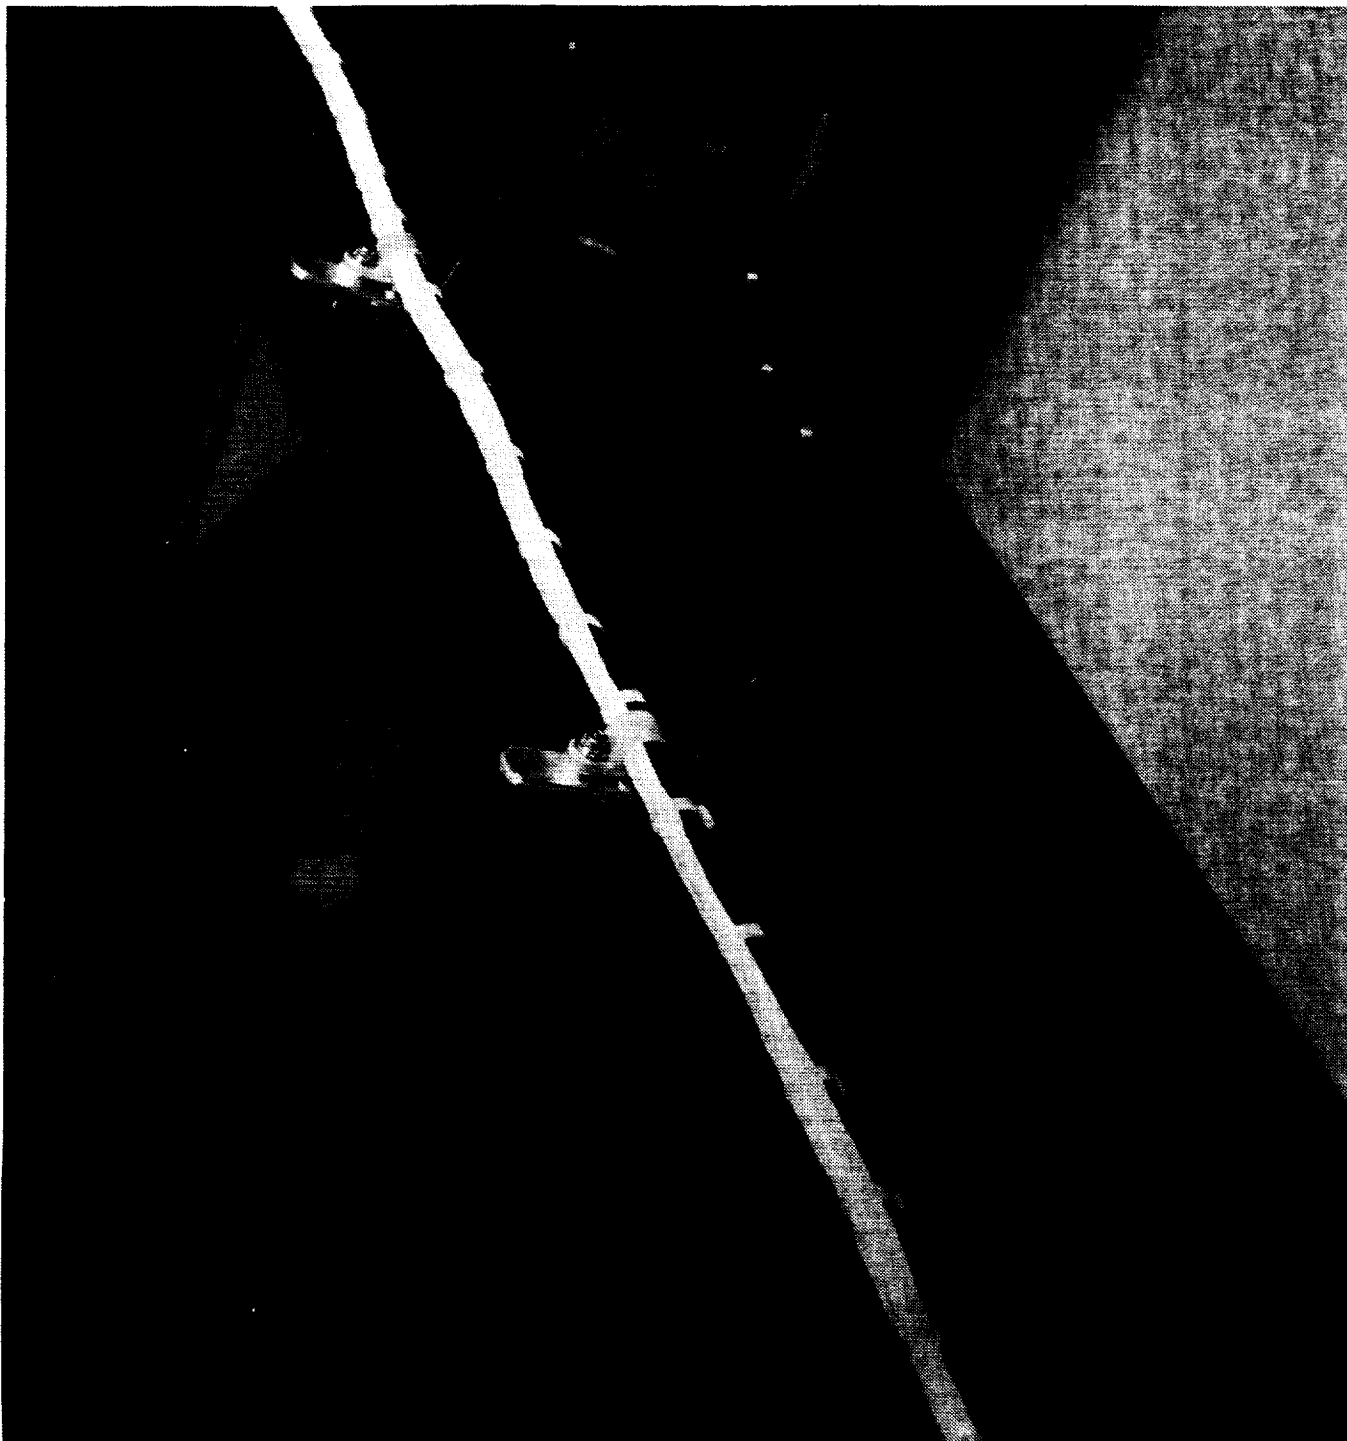
Figure 13. NASA photo of wiring and associated wire harness clamps along the longeron between row 1 and row 12, Bay A. Earth end of LDEF is toward the bottom of the page.

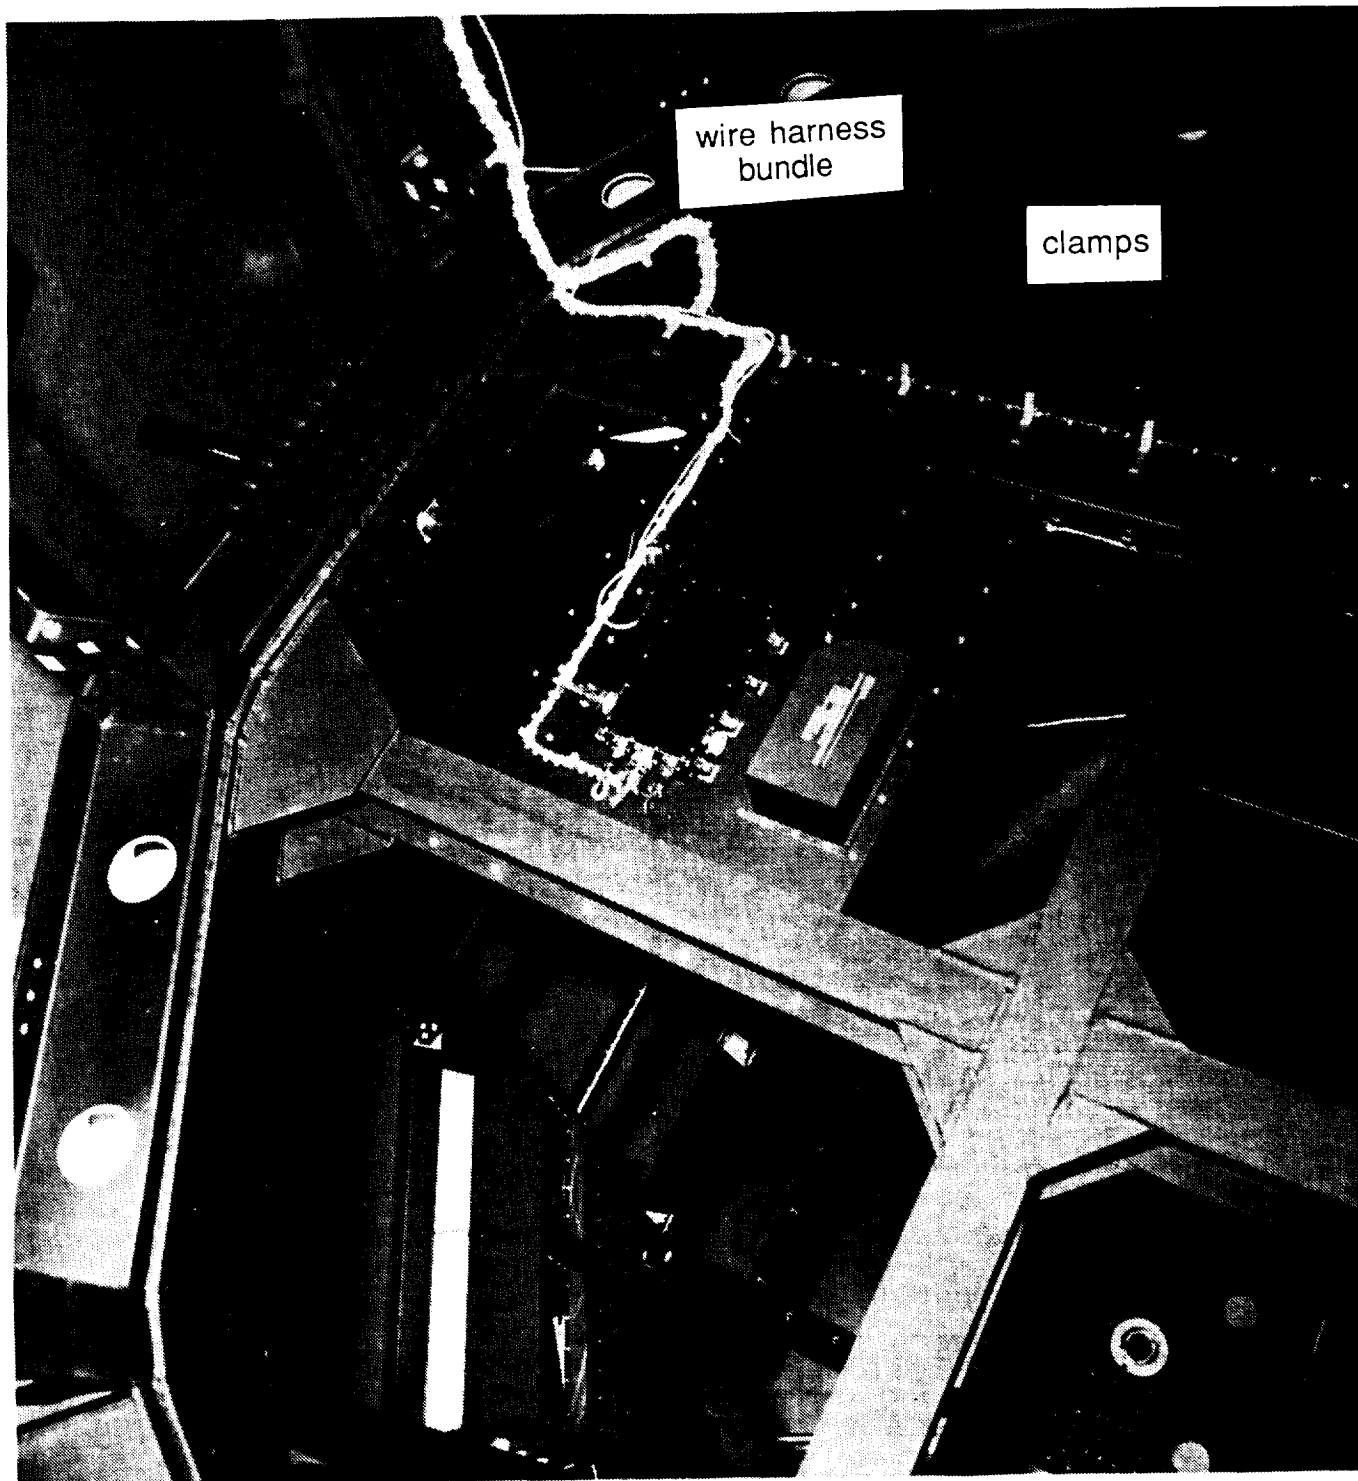
Figure 14. NASA photo of center ring viewed from space end of LDEF. Row 6 keel pin is at upper left. Center ring clamps and wire harness bundles are clearly visible.

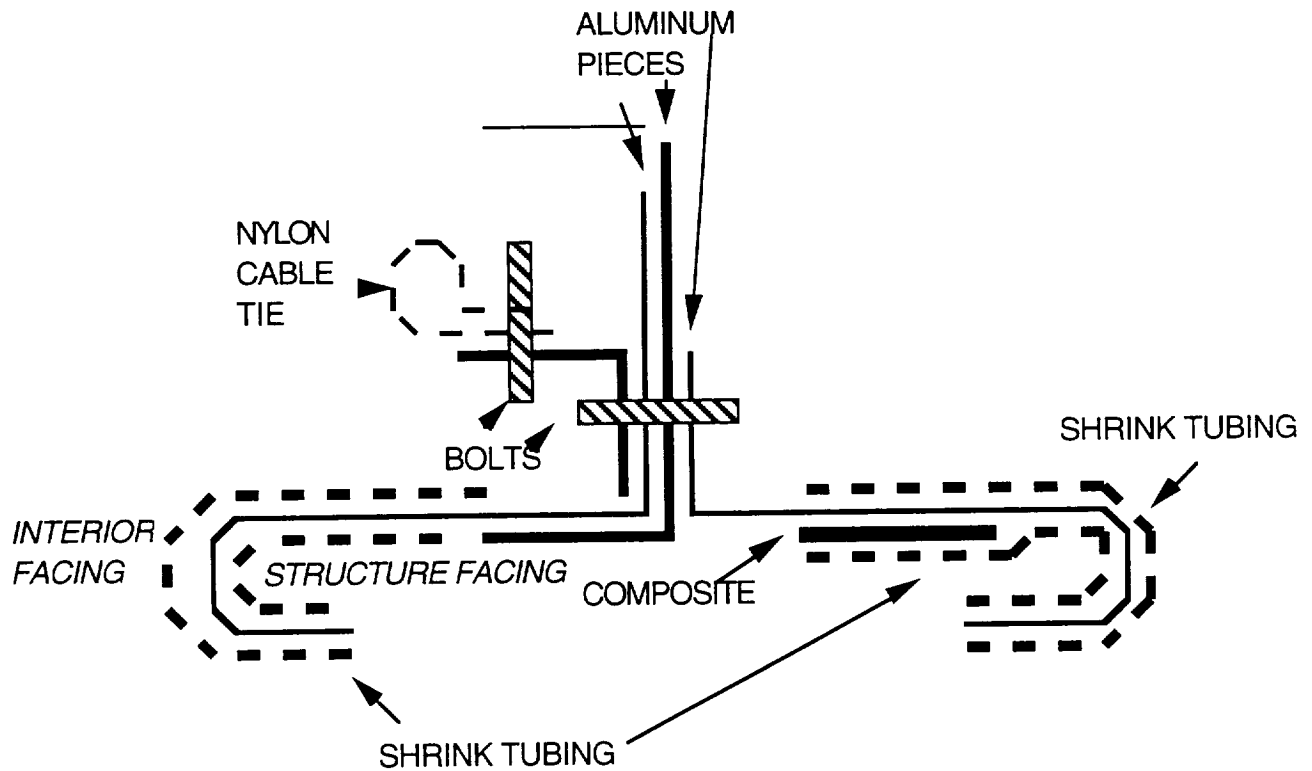
Figure 15 Location of components on wire harness clamps.

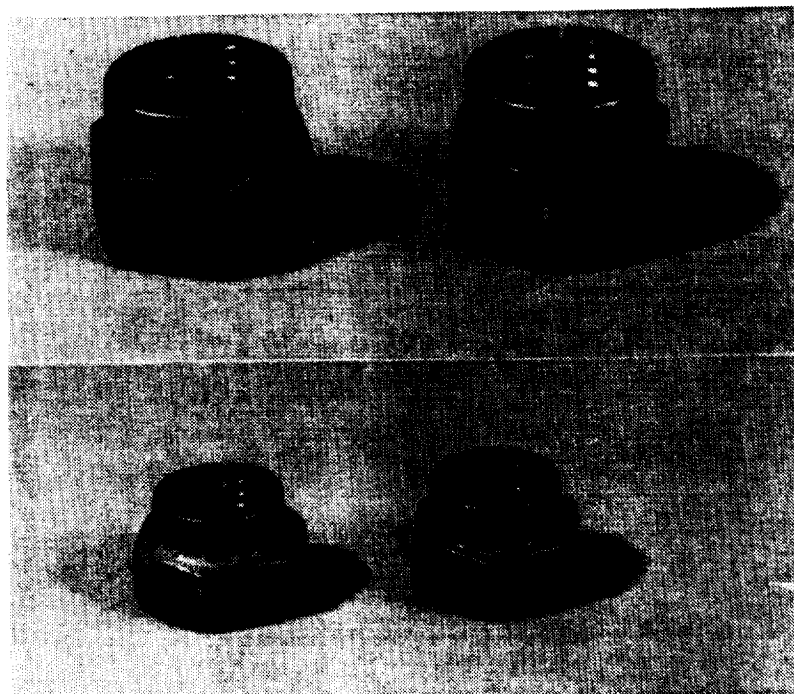
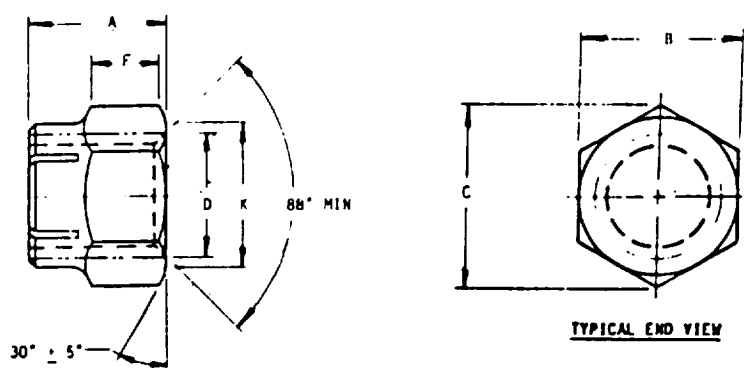
Photographs were taken of all the nuts before any testing. A photograph of a typical hex nut is shown in figure 17. All of the nuts were tarnished or coated. The color and distribution of tarnish varied between nuts and over the surface of each nut. There was no apparent correlation between the location of the nuts and the amount of tarnish. The tarnish was scratched on the edges of the flats where the wrench had loosened them. No other erosion or degradation of the protective silver coating was observed by photomicroscopy of the surfaces and/or cross-sections.

Figure 17. Photograph of silver-plated nuts at 2X magnification and corresponding diagram and data for each nut type.

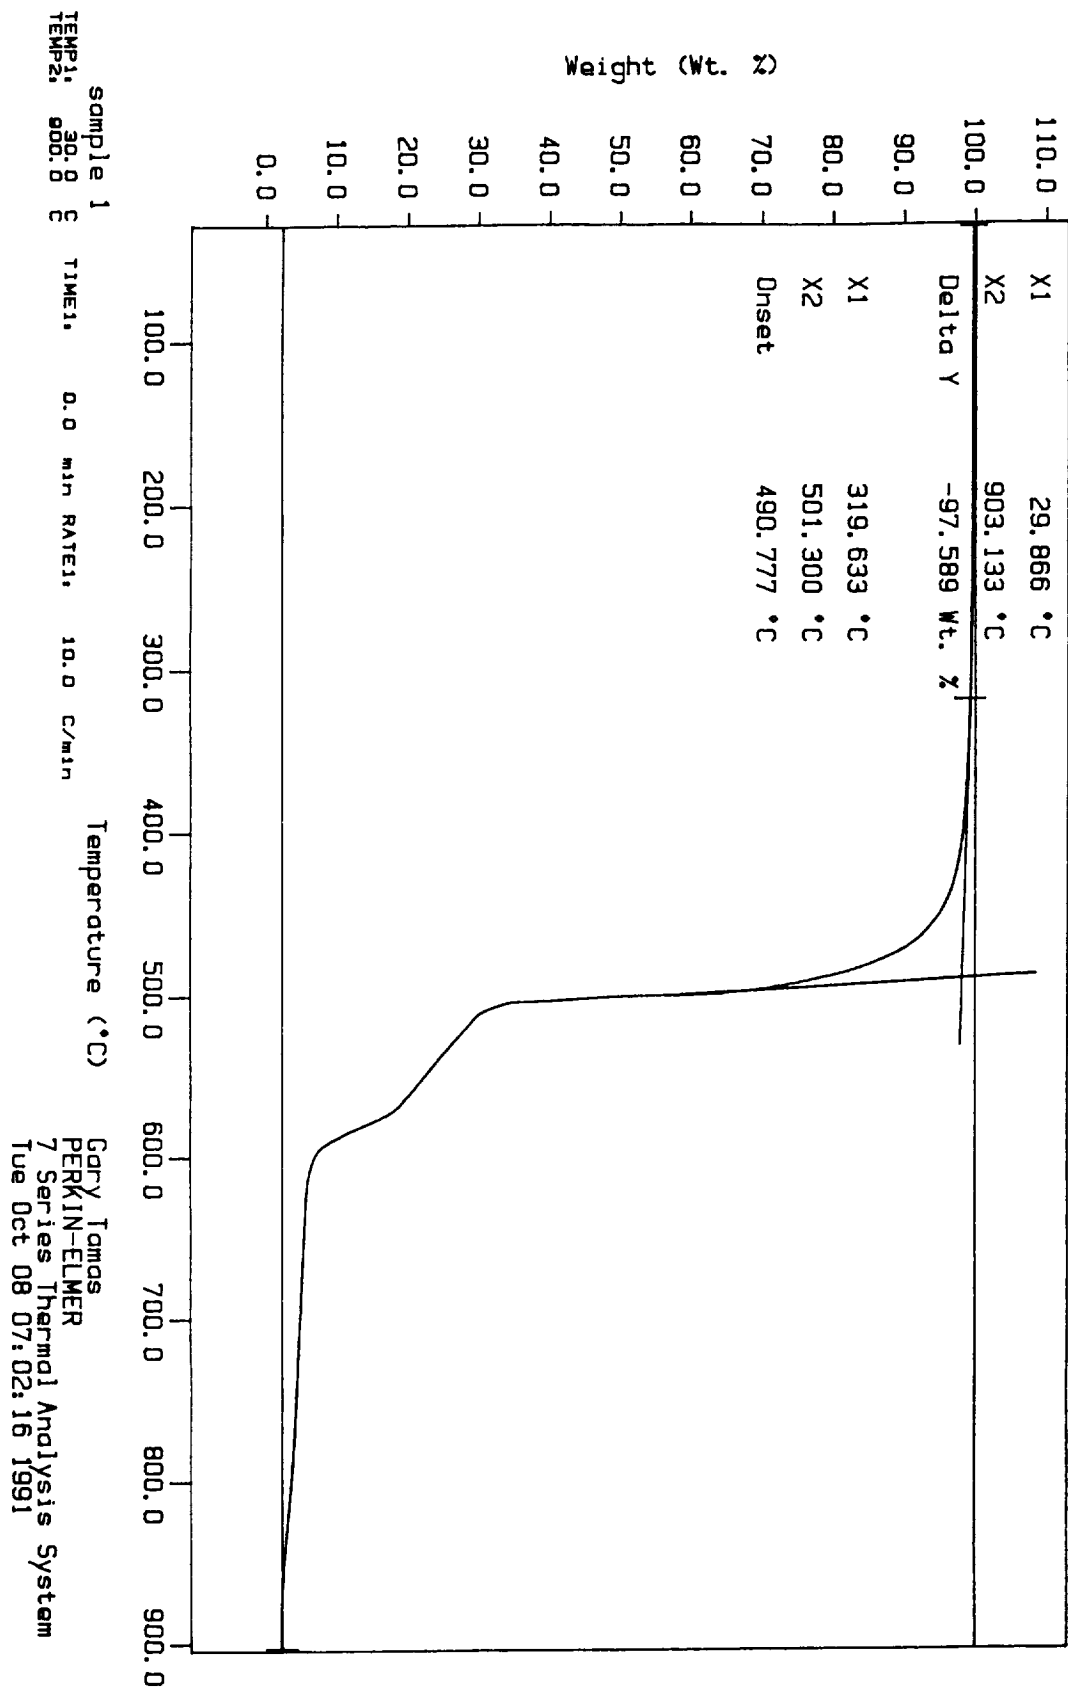
Figure 1. TGA measurement for structure-facing heat shrink tubing specimen D3.

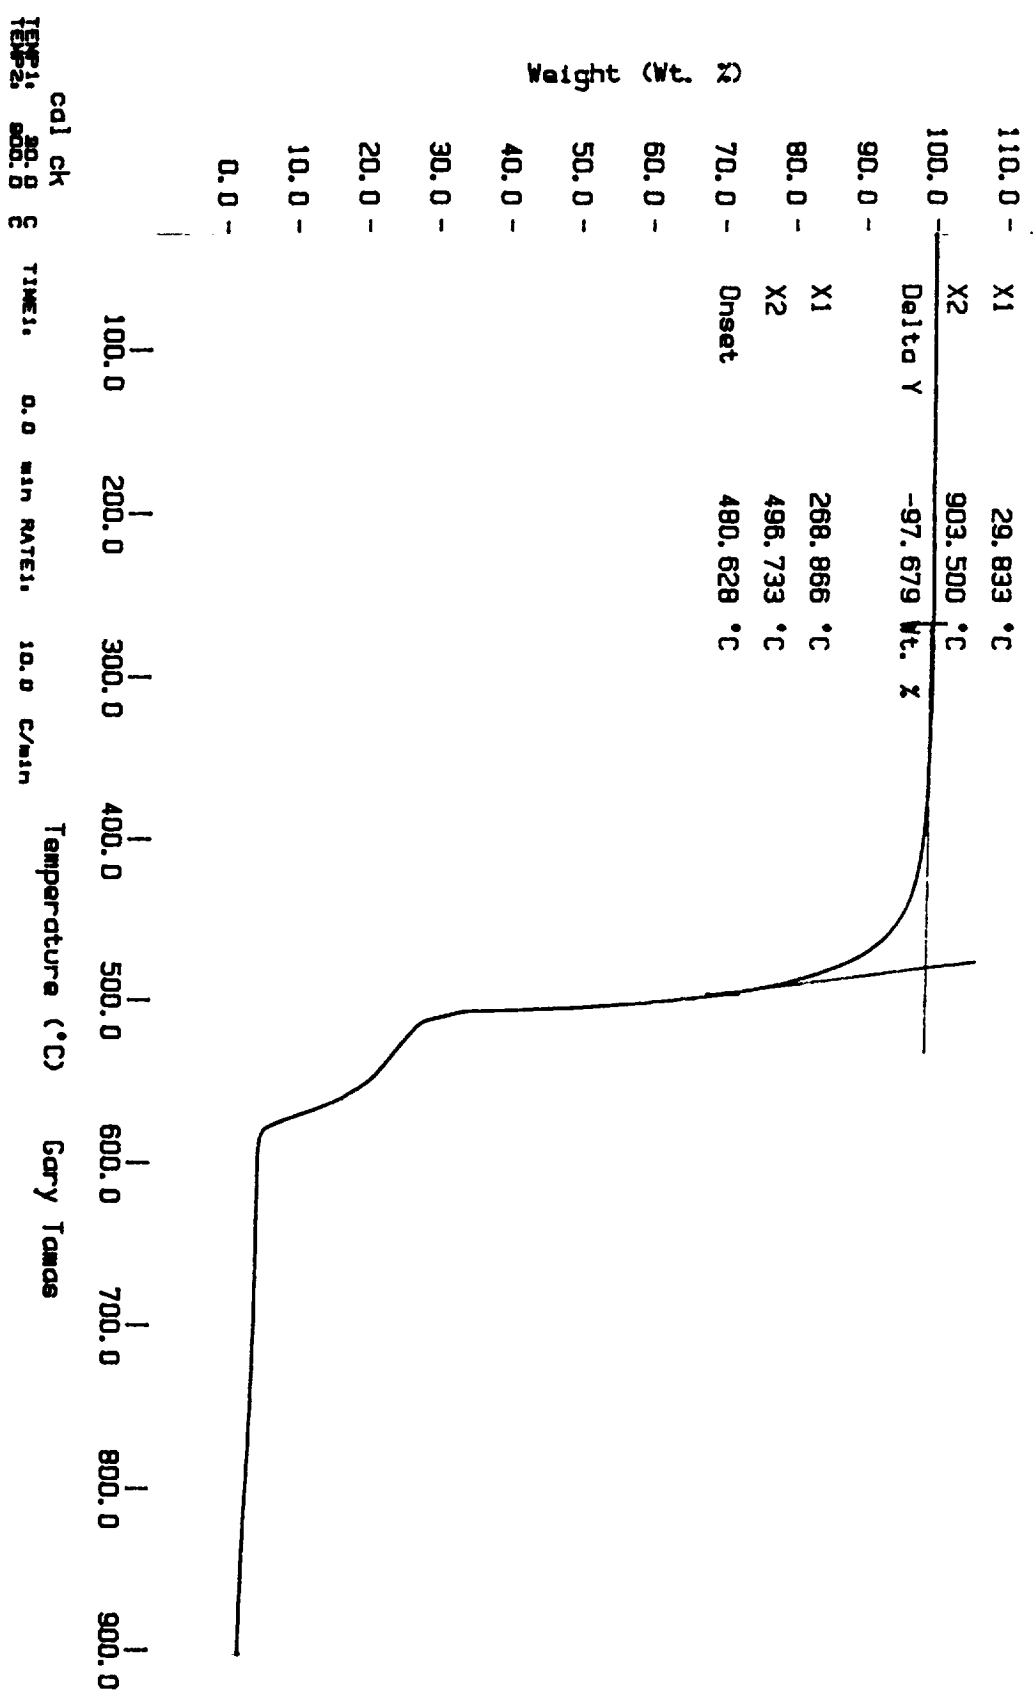
Figure 2. TGA measurement for structure-facing heat shrink tubing specimen D3.

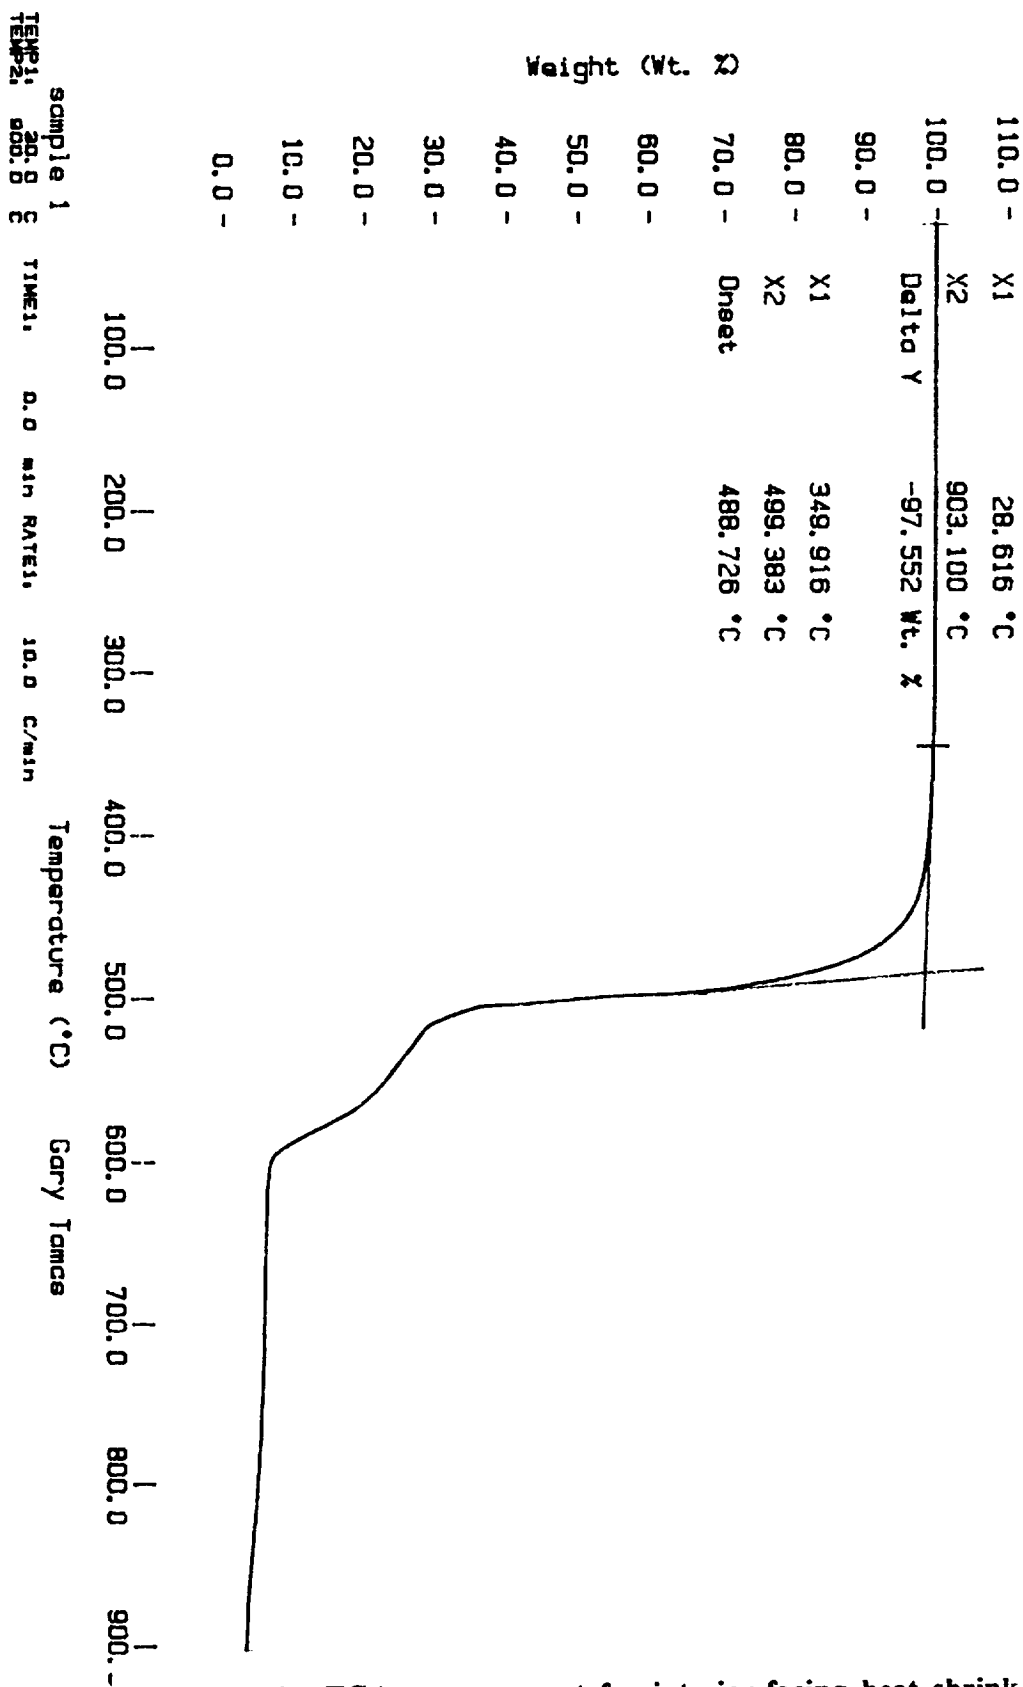
Figure 3. TGA measurement for interior-facing heat shrink tubing specimen D3.

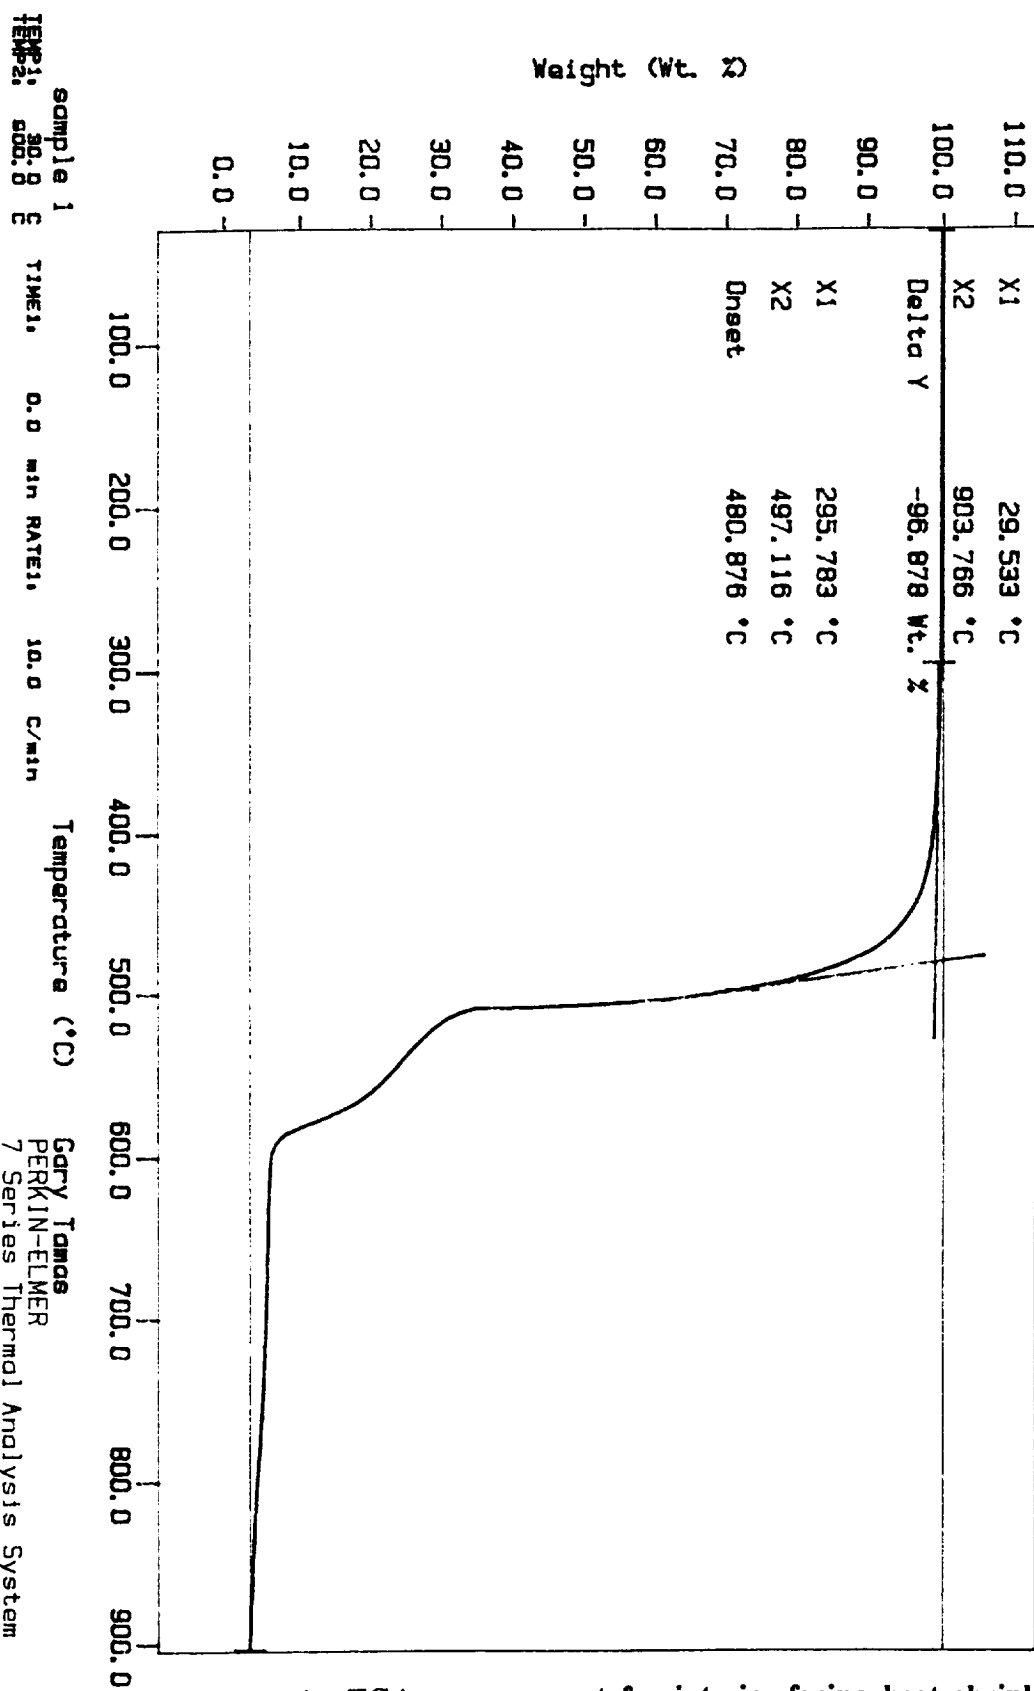
Figure 4. TGA measurement for interior-facing heat shrink tubing specimen D3.

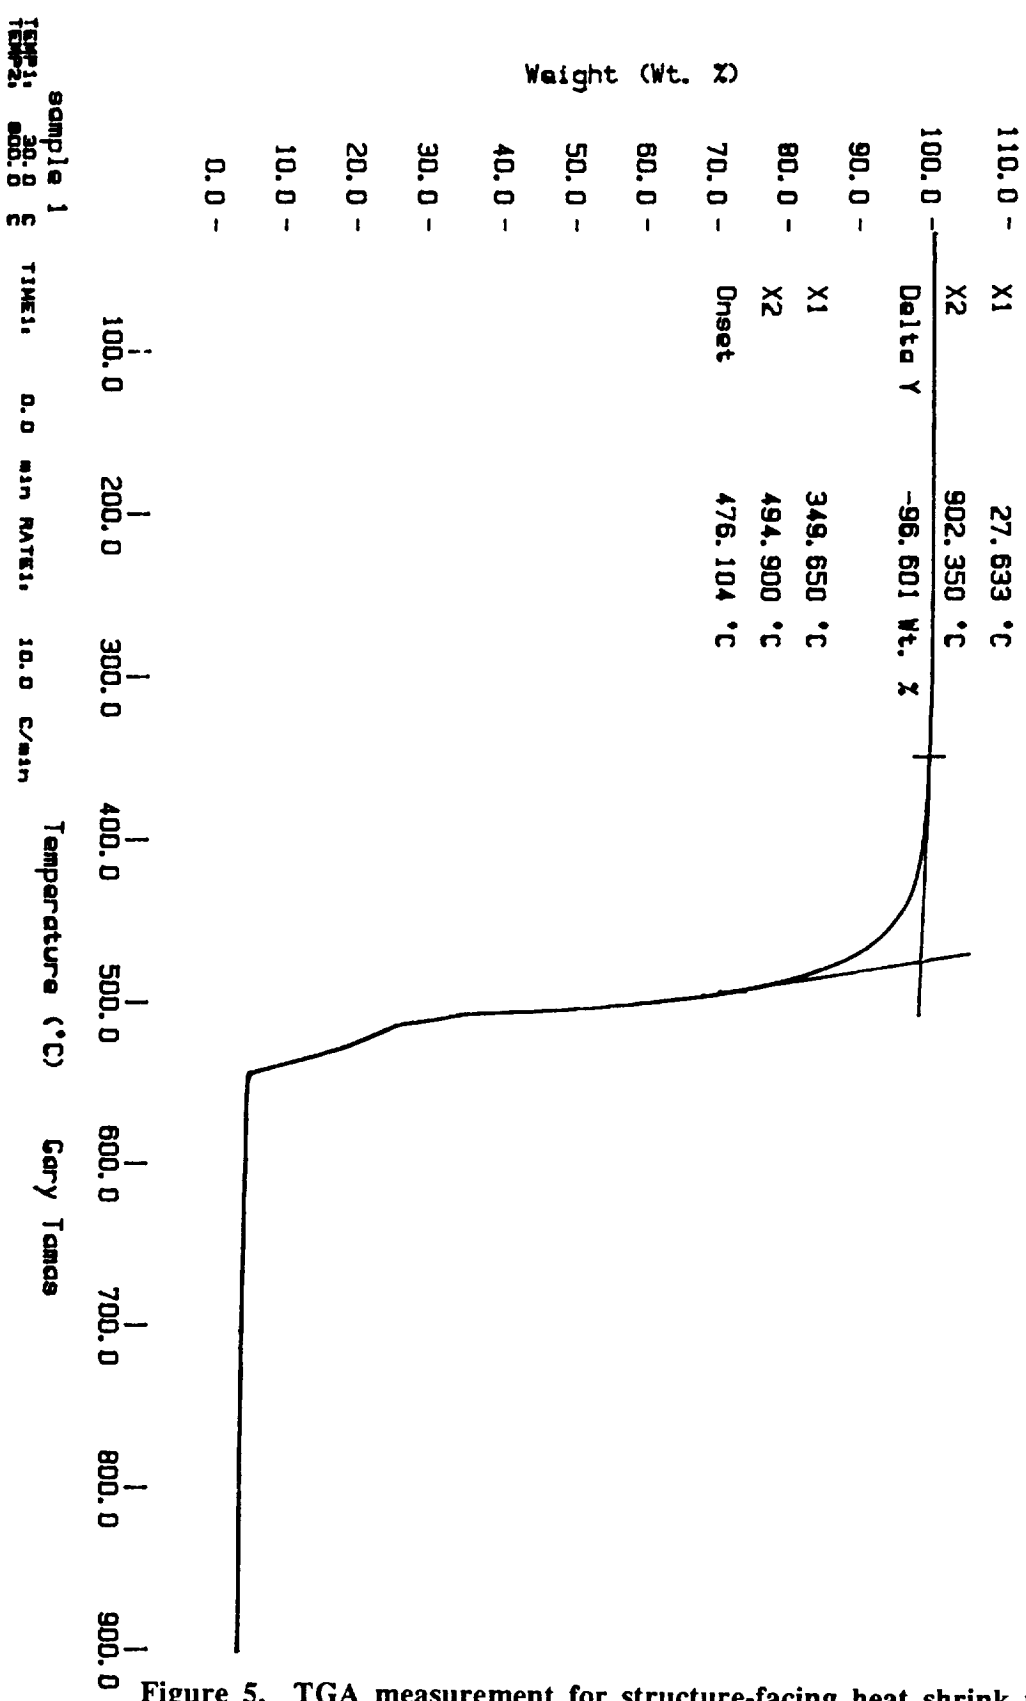
Figure 5. TGA measurement for structure-facing heat shrink tubing specimen J6.

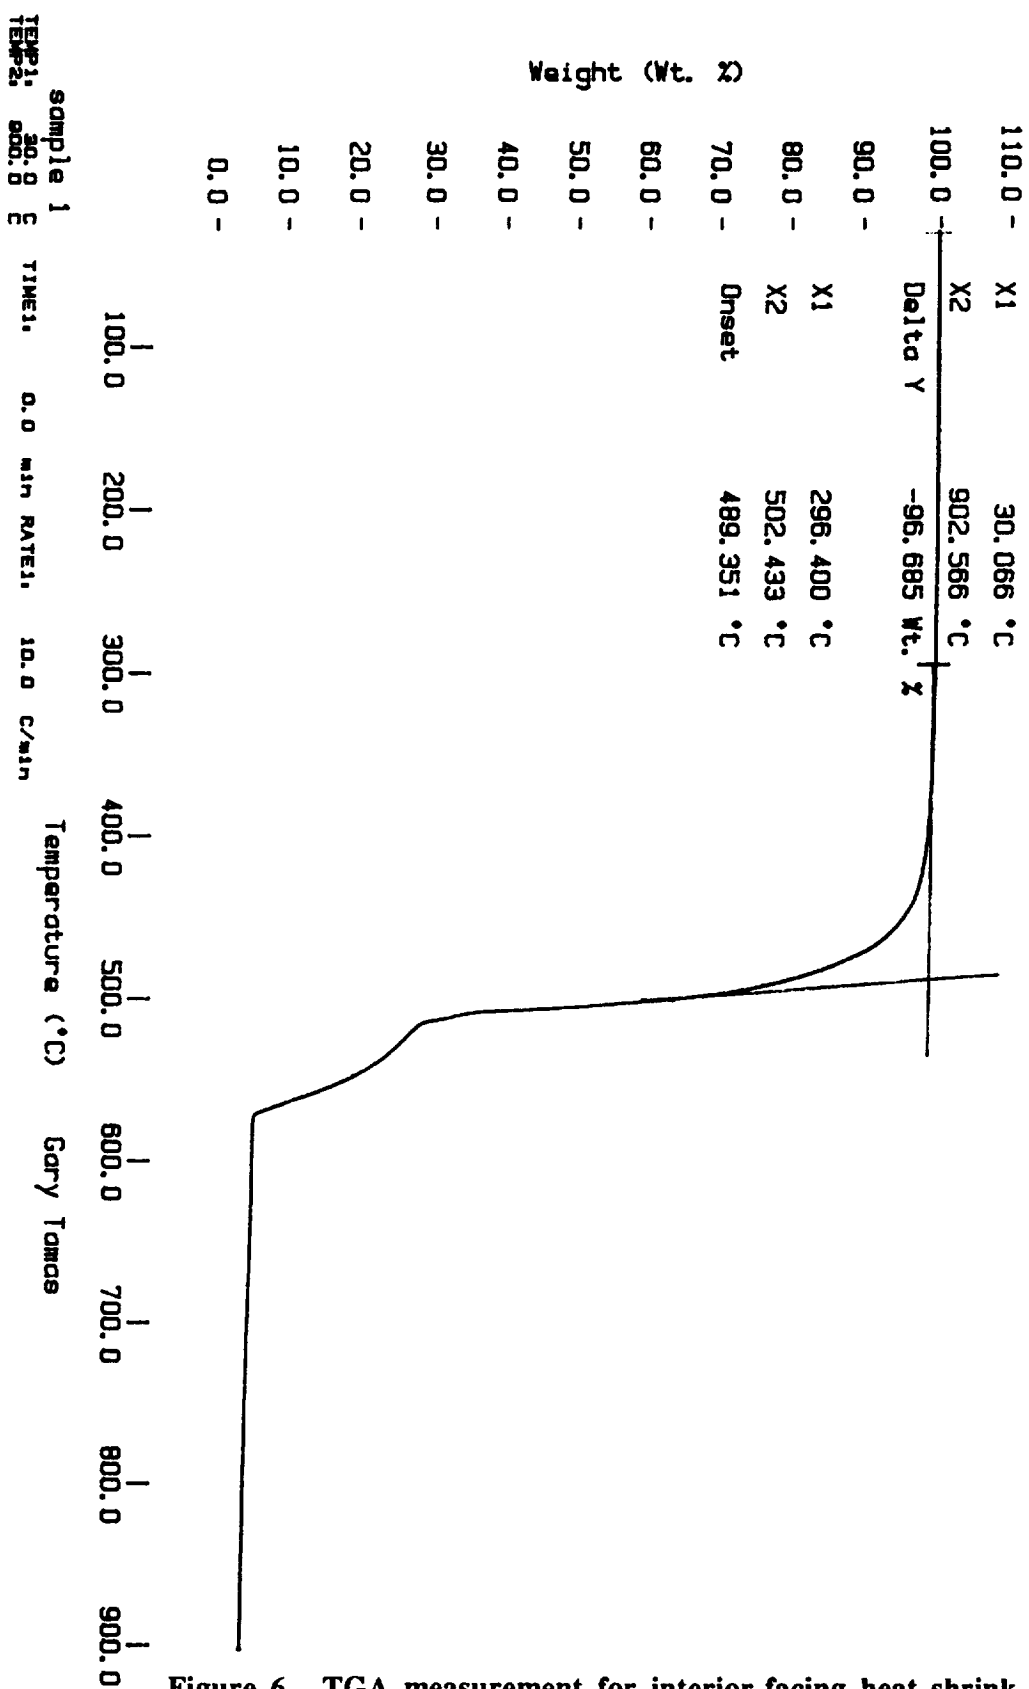
Figure 6. TGA measurement for interior-facing heat shrink tubing specimen J6.
